# SNOQUALMIE RIVER SURVEY: Access Points

**King County**  
Department of Natural Resources and Parks  
Water and Land Resources Division

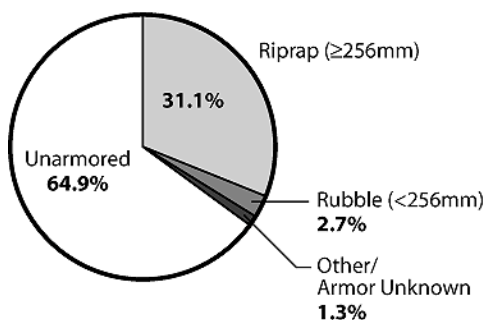
Figure 12.

### Toe of Left Bank Armor Types

miles on the toe of the left bank (LB—the bank on the left side of the river when looking downstream) and on 29.5% of river miles on the upper LB. There was bank hardening on 30.4% of river miles on the toe of the right bank (RB—the bank on the right side of the river when looking downstream) and on 29.4% of river miles on the upper RB. Riprap was found more frequently than rubble on both banks (Figures 6 to 15). The bank hardening percentages may actually be higher because some bank hardening is covered in silt and partially vegetated and therefore would not have been visible from the river during the habitat conditions inventory. Nevertheless, it remains effective hardening because it arrests channel migration and natural bank erosion critical for forming and rejuvenating habitat (Anderson, 2002).

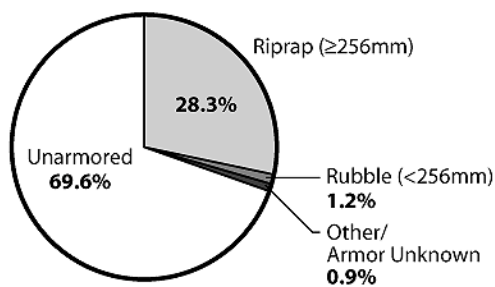
Figure 13.

### Toe of Right Bank Armor Types

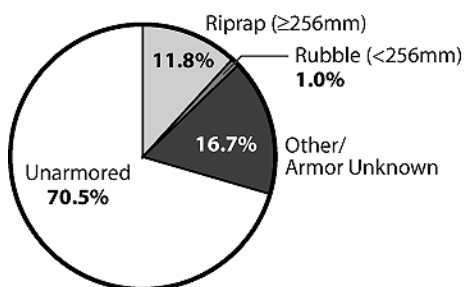
Figure 14.

### Upper Left Bank Armor Types

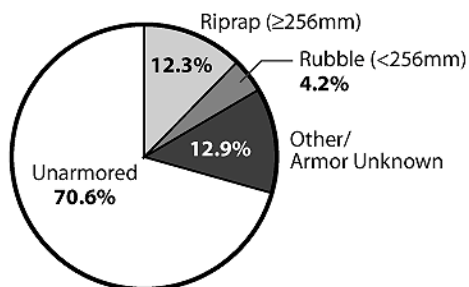
Figure 15.

### Upper Right Bank Armor Types

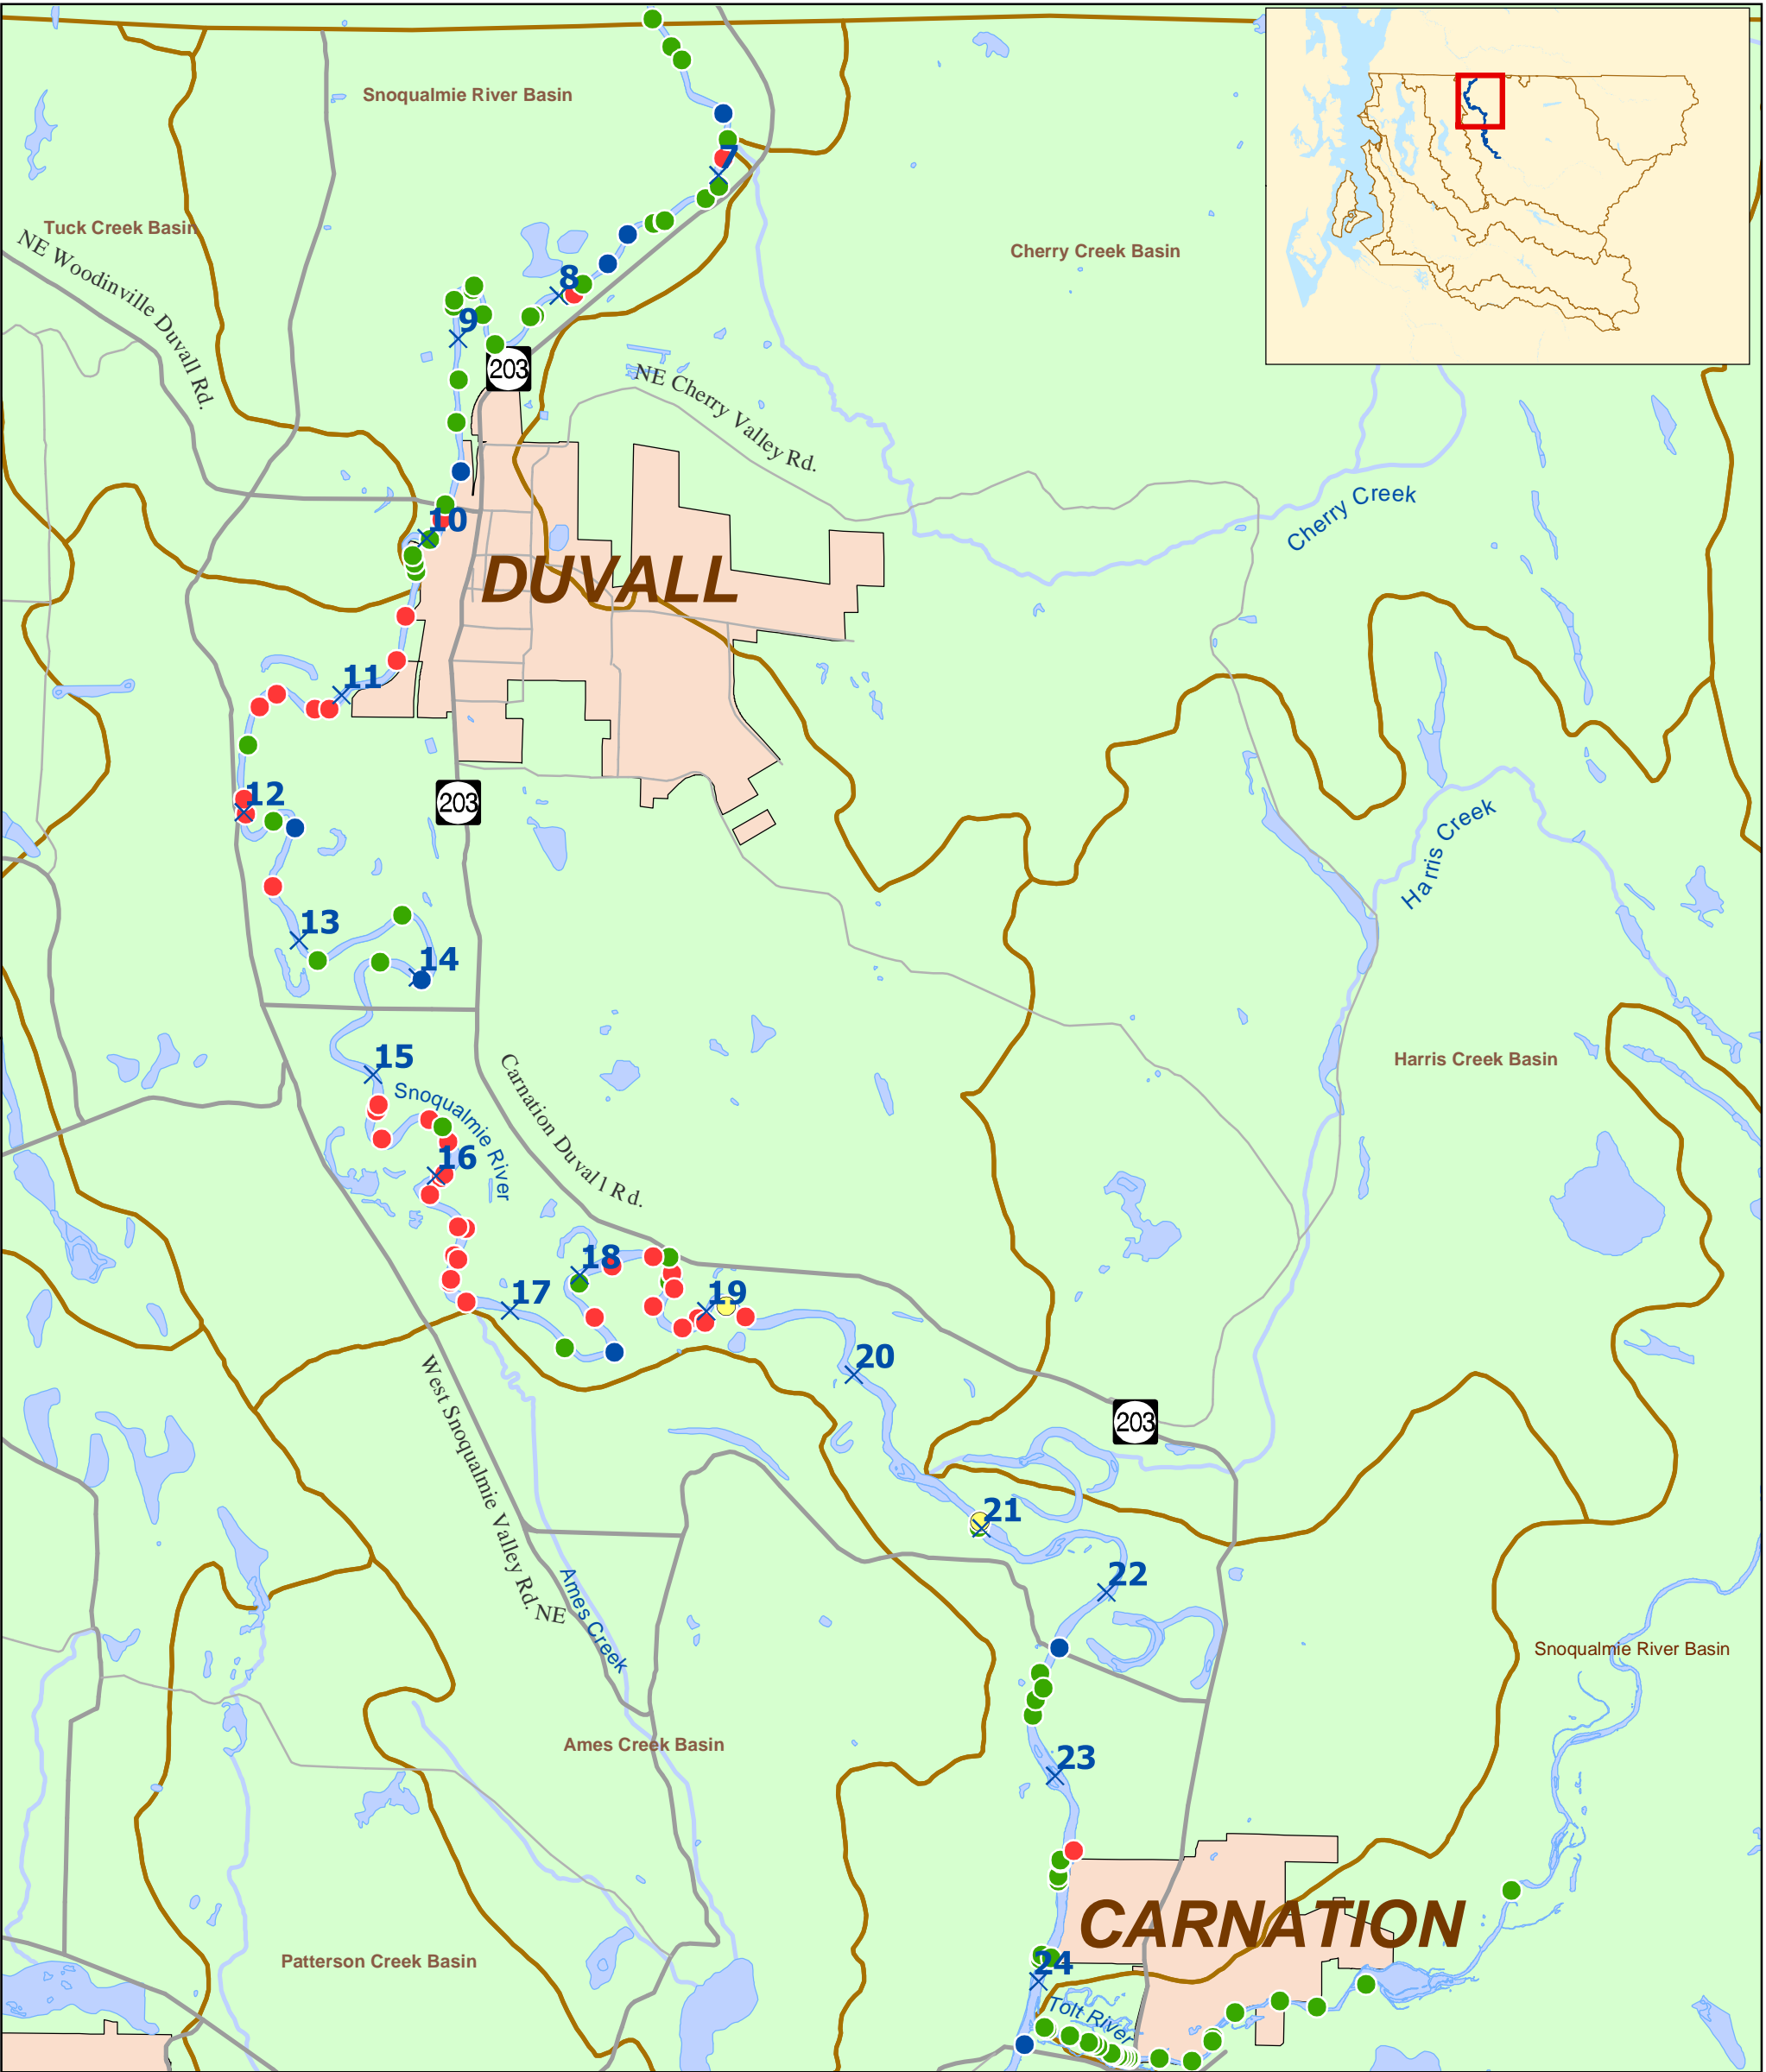
Figure 16.

Figures 16 and 17 show the location of cattle, human, boat, and other vehicle access to the Snoqualmie River. There was a correlation between riverbank erosion and human or cattle access to the river. For example, bank slumping was observed immediately downstream of RM 7 and RM 8, and between RM 9-10 at locations where people could easily walk down the banks to the river. Bank scouring was observed between RM 9-10 and at RM 25.3, again at locations where people could access the river.

Although there were locations throughout the study area where cattle could access the river, most of the cattle access points were concentrated in the Agricultural Production District (APD) between the City of Duvall and the Harris Creek confluence (RM 10-19). Erosional features and cattle access coincided at RM 10.5, 12, 12.5, 16.5, 16.7, 17.7, and 19. Cows were observed grazing on top of the riverbanks at some locations and wading in the river at others. Horses were occasionally observed as well. For example, on August 31, 2000, the field team counted 17 cows and calves and one bull on the riverbanks, in the river, and on a gravel bar in one area between RM 16.5-16.7.

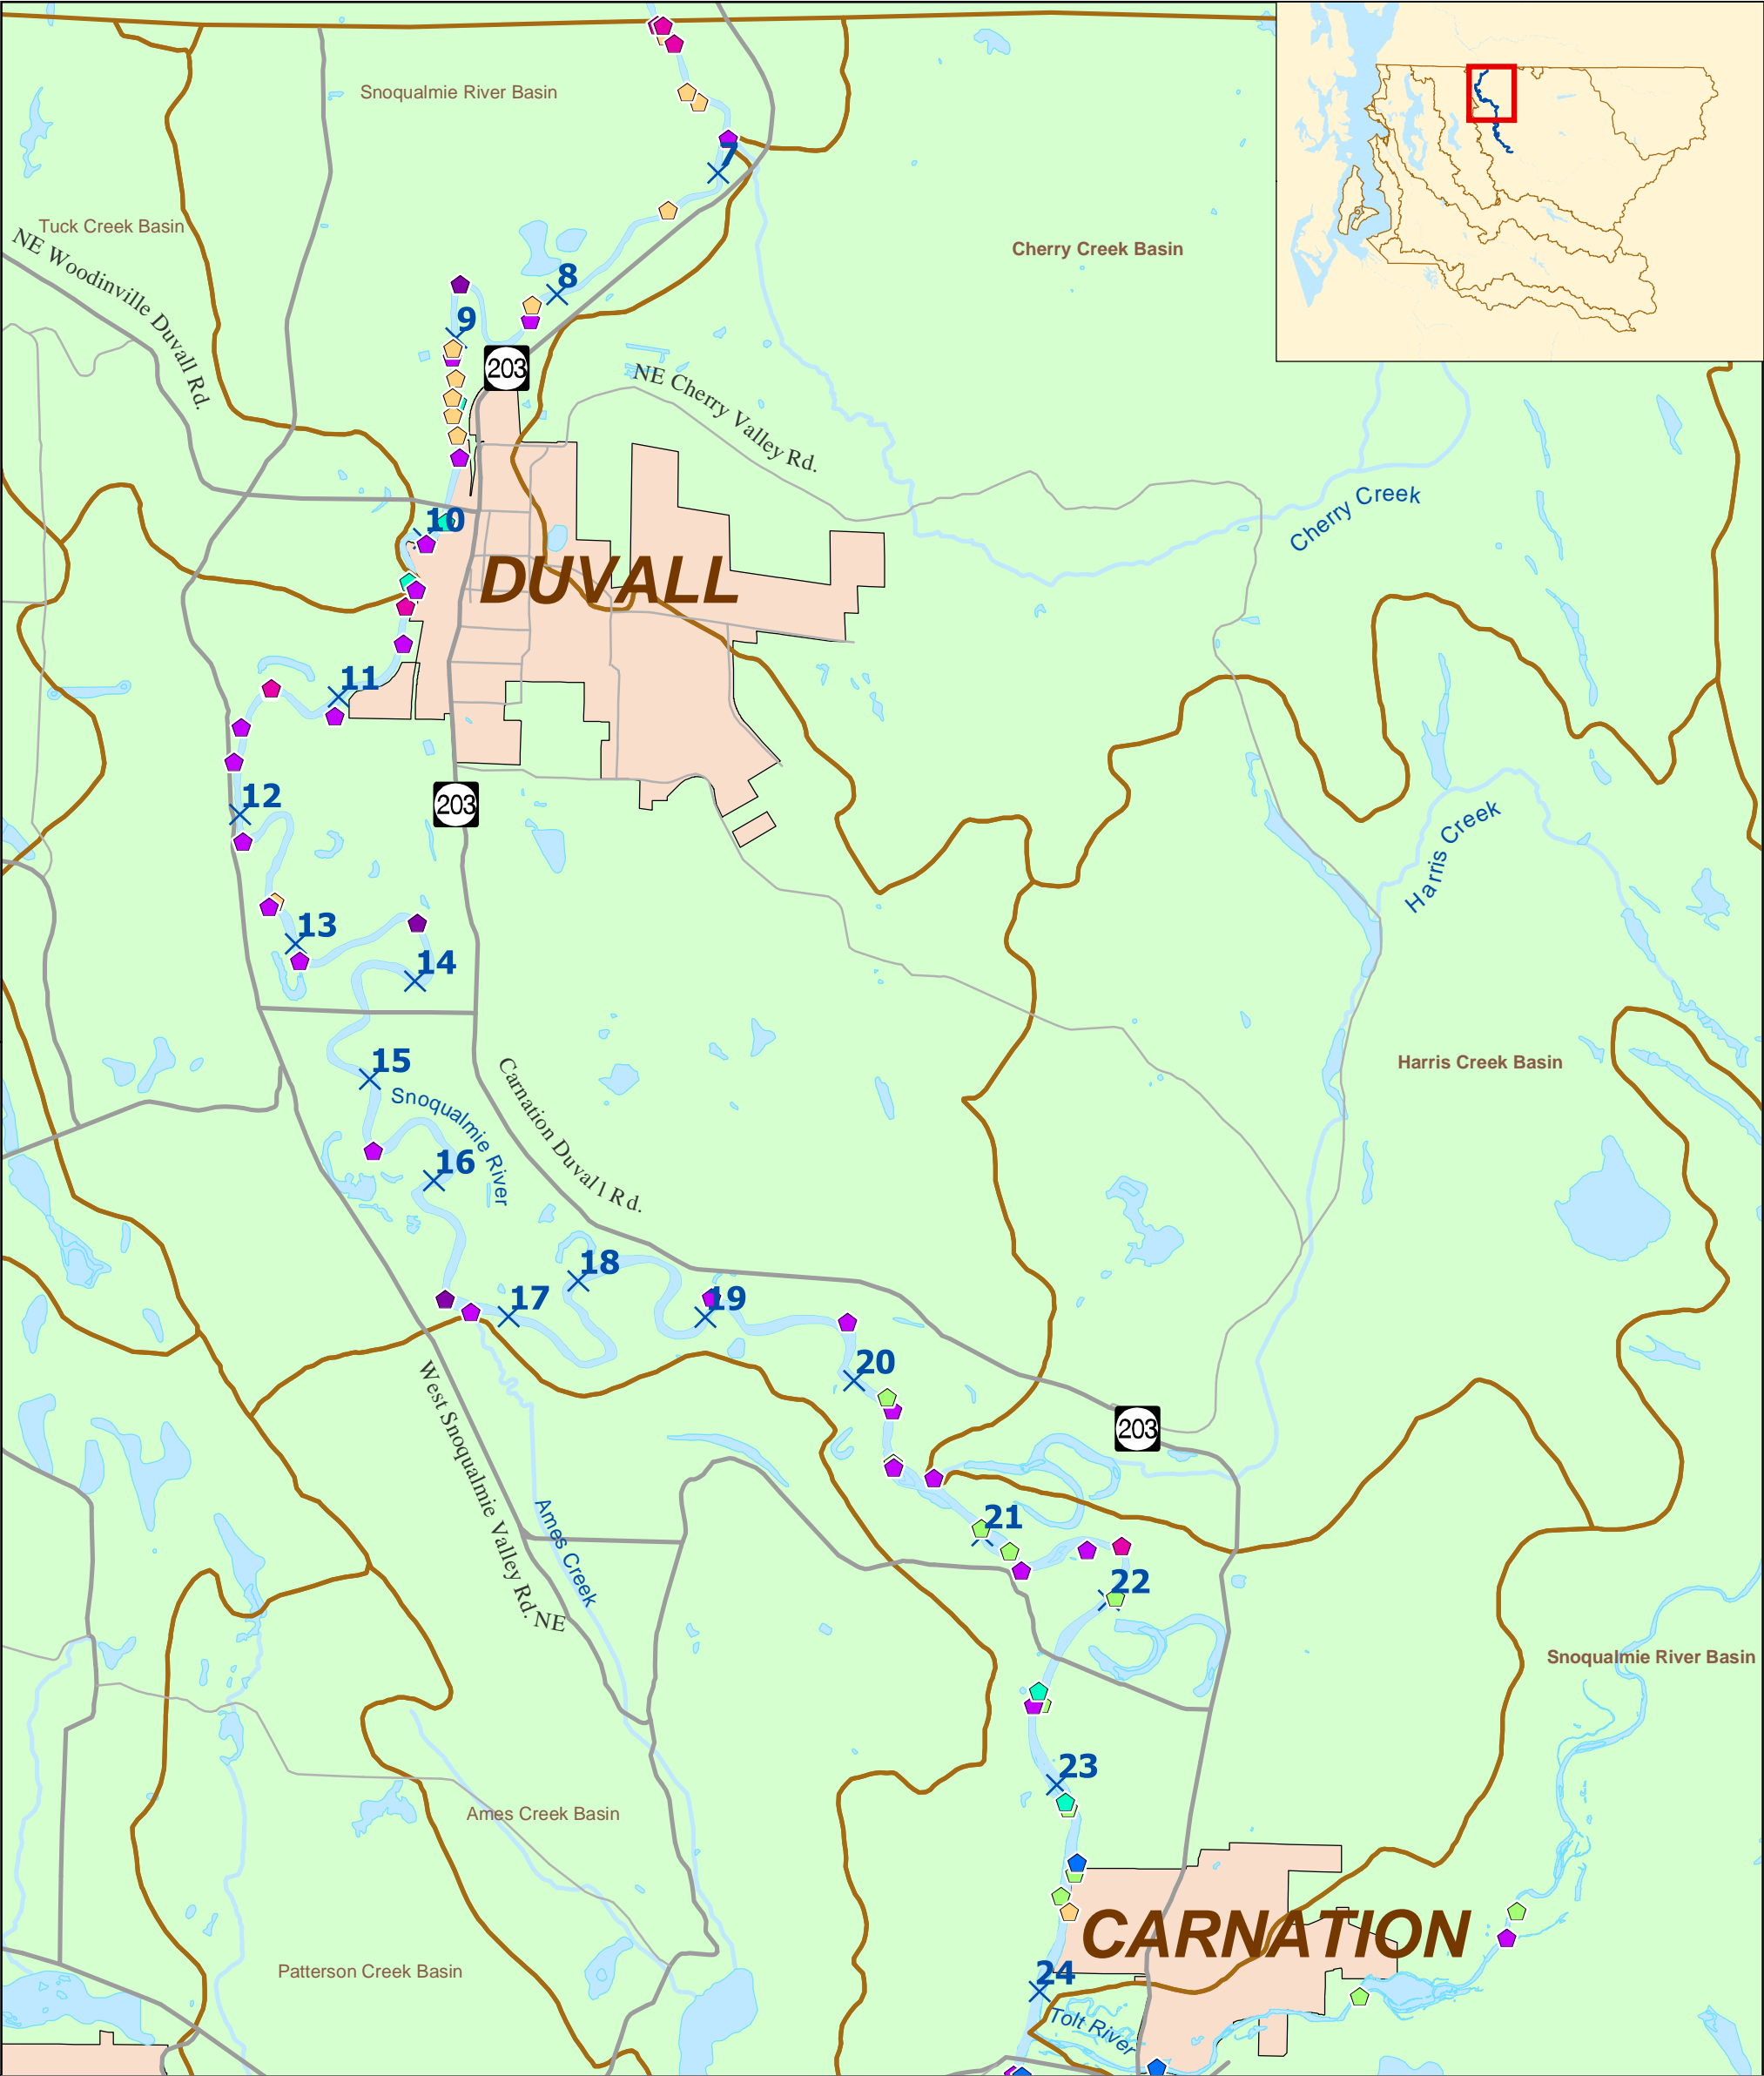
Figures 18 and 19 show the location of floodplain features including the mouths of major tributaries (e.g., Cherry Creek, Harris Creek, and Griffin Creek) and small, unnamed tributaries as well as back channels, water diversion pumps, culverts, and flap gates. A flap gate is a flexible (normally hinged) covering of the outlet of a culvert designed to block high water from entering flood prone areas behind dikes and to allow drainage of water into a river’s main channel during normal, nonflood conditions.

Forty-six small, unnamed tributaries and 26 back channels were observed. Tributaries and back channels can provide good edge habitat for summer rearing and winter refuge for salmonids. These valley floor habitat features as well as wetlands and oxbows will be inventoried for habitat conditions and fish use in the summer of 2003.

Most of the water diversion pumps (10 out of 15) were located in the reach between the King-Snohomish County line and the City of Duvall (RM 6-10). The land in this reach is in the APD. It is likely that water is being withdrawn from the Snoqualmie River for irrigating crops and for drinking water for cattle. However, no assessment of diversions was made.

Eight flap gates and 15 culverts were observed throughout the study area. Water diversion pumps, flap gates, and culverts, especially perched culverts, can be barriers to fish habitat. These barriers can adversely affect juvenile and adult salmonids by eliminating or restricting access to upstream rearing and spawning habitat. Fish passage barriers can also cause reduced flow to downstream areas, thereby exacerbating passage problems, reducing the amount of refuge habitat, and decreasing the area and quality of food production for juveniles. Fish passage barriers restrict access to off-channel refuge habitat during high flow events as well (Snohomish Basin Salmonid Recovery Technical Committee, 2002).
